7th European Workshop on
Standardized Procedure for the Inspection of
Sprayers in Europe

Assessment of the sprayer inspection results in Catalonia

F. Solanelles, F. Camp, A. Fillat, F. Gracia
*Centre de Mecanització Agrària
Rovira Roure, 191. Lleida*

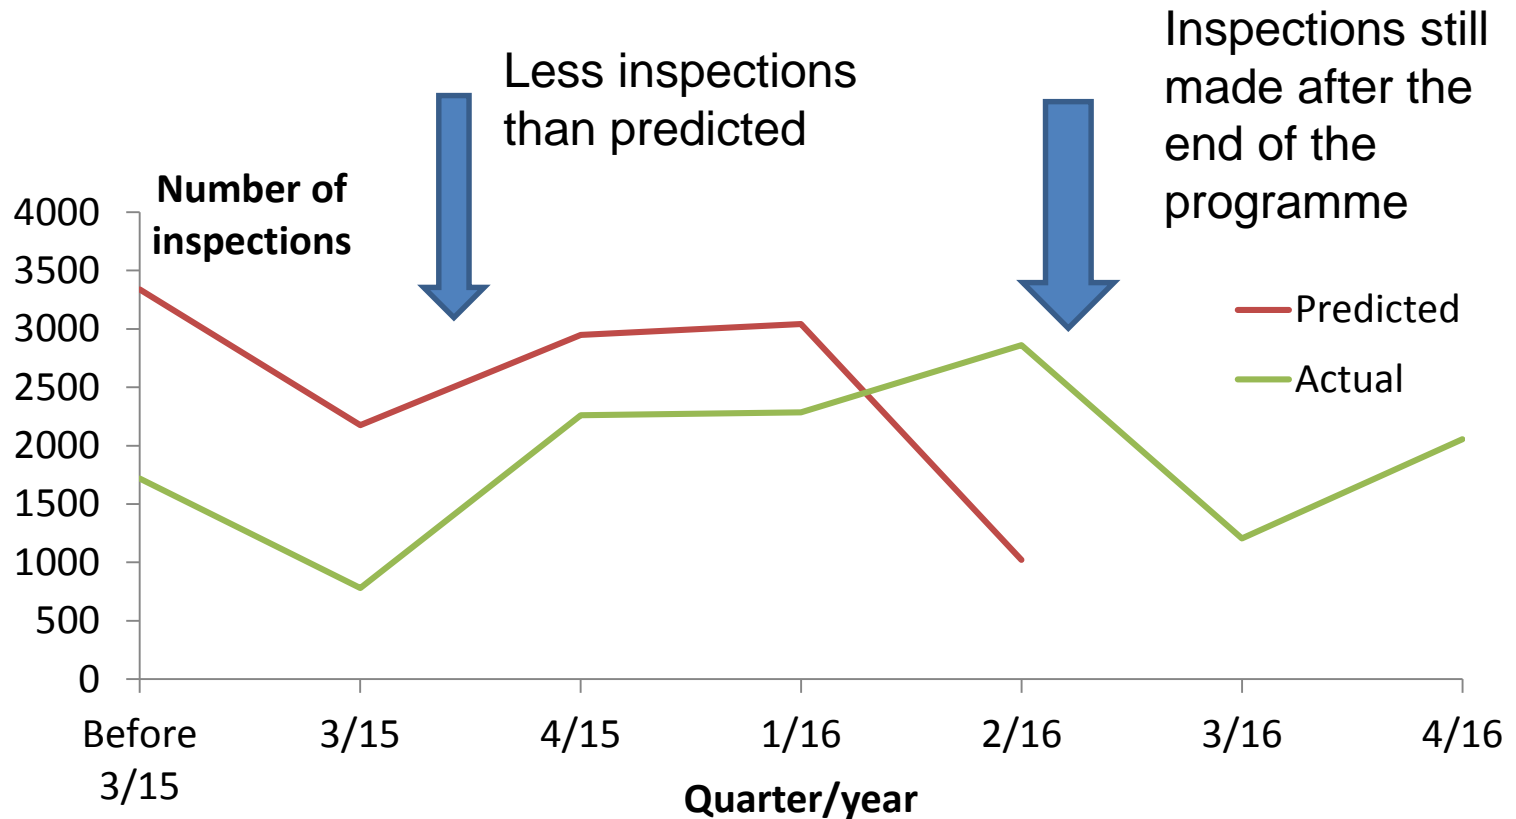
Quarterly evolution of the inspections predicted in the programme and the actual inspections

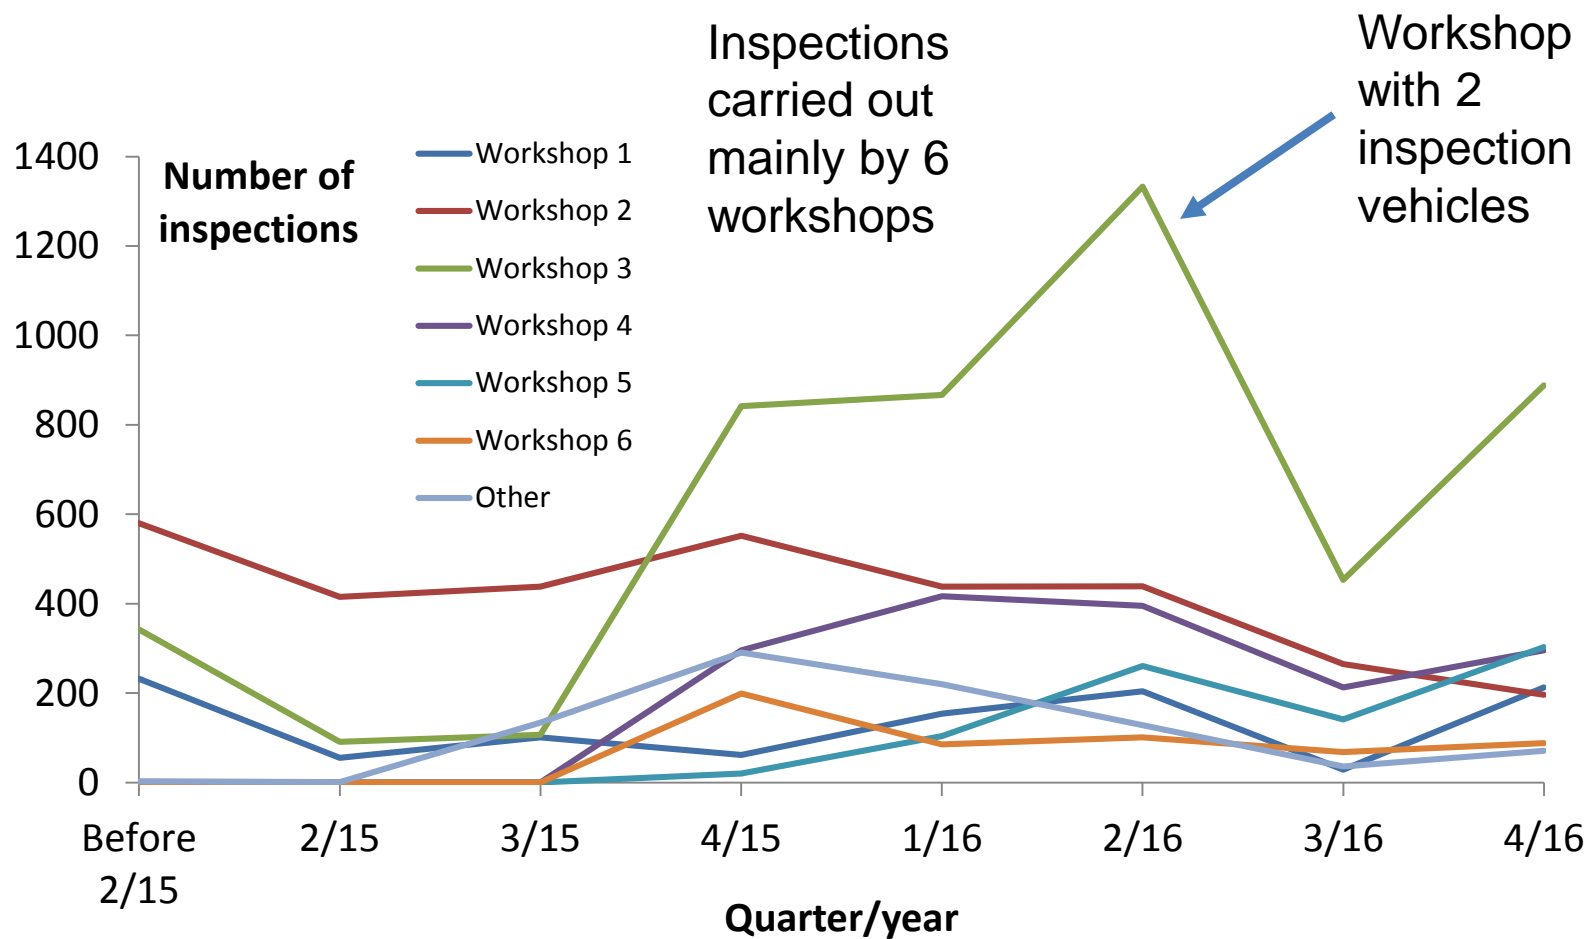
Quarterly evolution of the inspections carried out by the different workshops

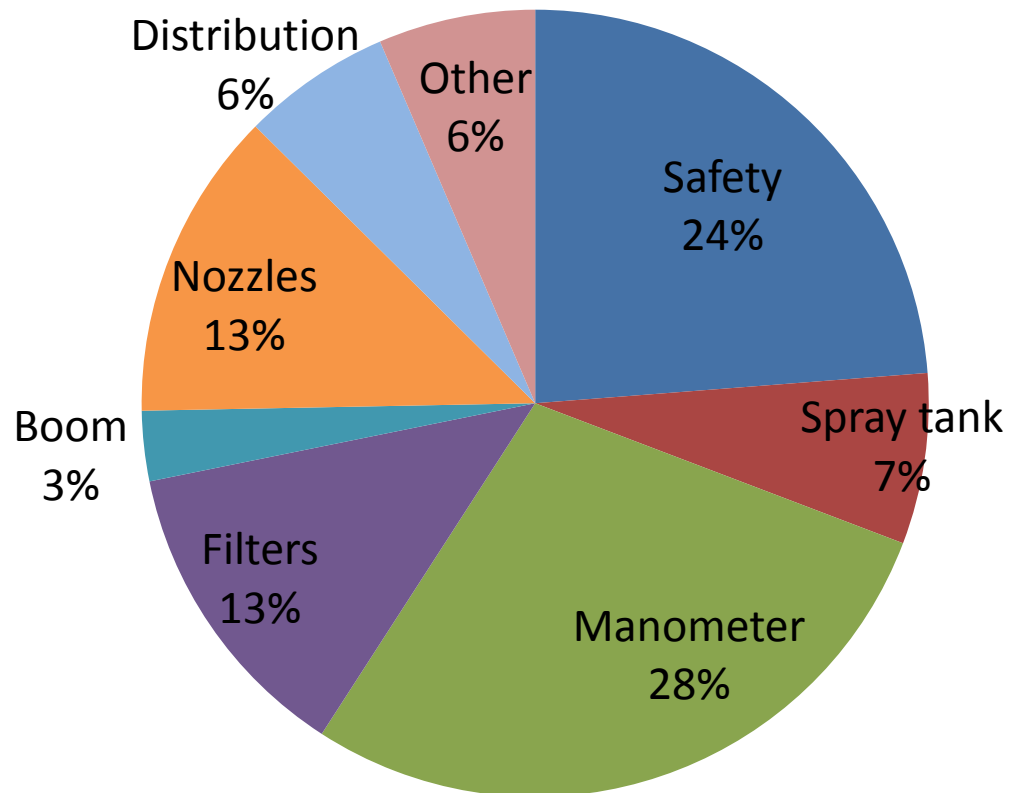
Percentage of defects found during the inspection of all types of pesticide application equipment

- The most frequent malfunction is related with the sprayer manometers. Inadequate scale or inaccuracy
- Protection of the operator. Guards of the sprayer moving parts deteriorated or missing
- Filters. Missing filters in the sprayer manifold
- Nozzles. Deviation from the nominal flow rate. Nozzles can be clogged or worn. Difficulties with some nozzle models
- Excessive pressure loss between the manometer and the nozzles

Percentage of defects found during the inspection of all types of pesticide application equipment

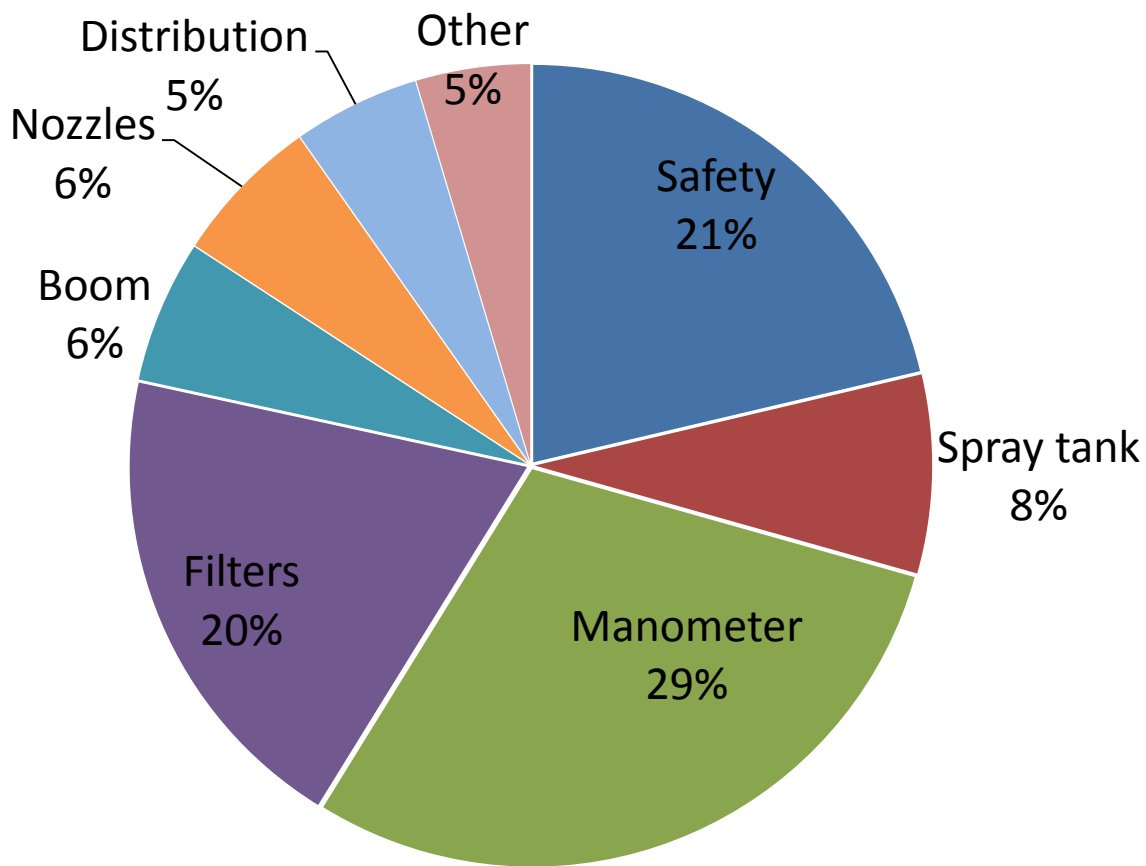
Percentage of defects found in the inspection of horizontal boom sprayers

- Higher percentage of defects in the filters. Small boom sprayers for herbicide band application don't have the required filters
- Sprayer tank. Tank contents indicator is not readable

Percentage of defects found in the inspection of horizontal boom sprayers

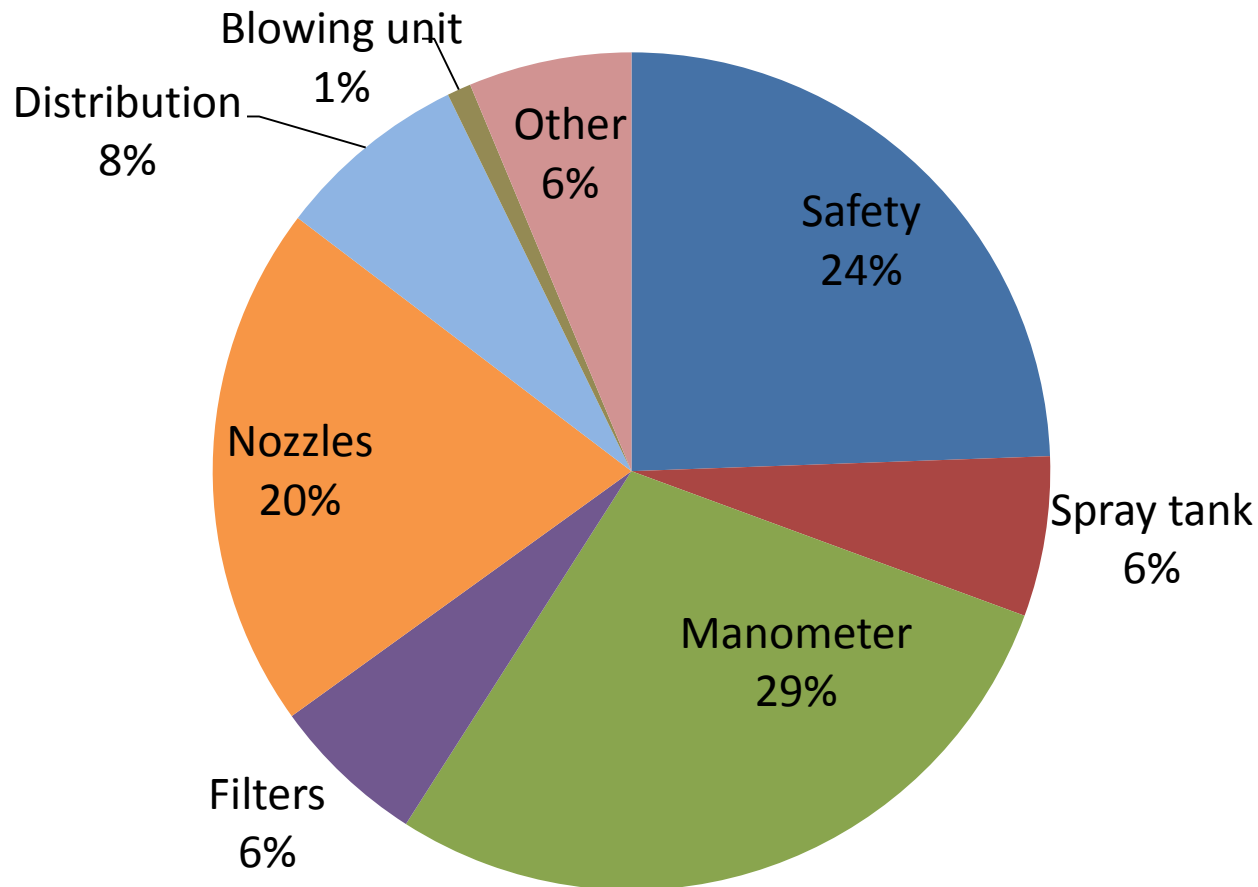
Percentage of defects found in the inspection of sprayers for bush and tree crops

- Higher number of nozzle defects. More nozzle models with adjustable spray jet width
- Defects of the blowing unit are mainly included in the safety section

Percentage of defects found in the inspection of sprayers for bush and tree crops
